PROPOSED
RECONSTRUCTION OF
THE
BEAVER PICNIC SITE / BEAVER GRAVEL PIT
TRAIL

GLACIER NATIONAL PARK

Prepared by : ✓ Geoff Smith
Date: May 4, 1986.

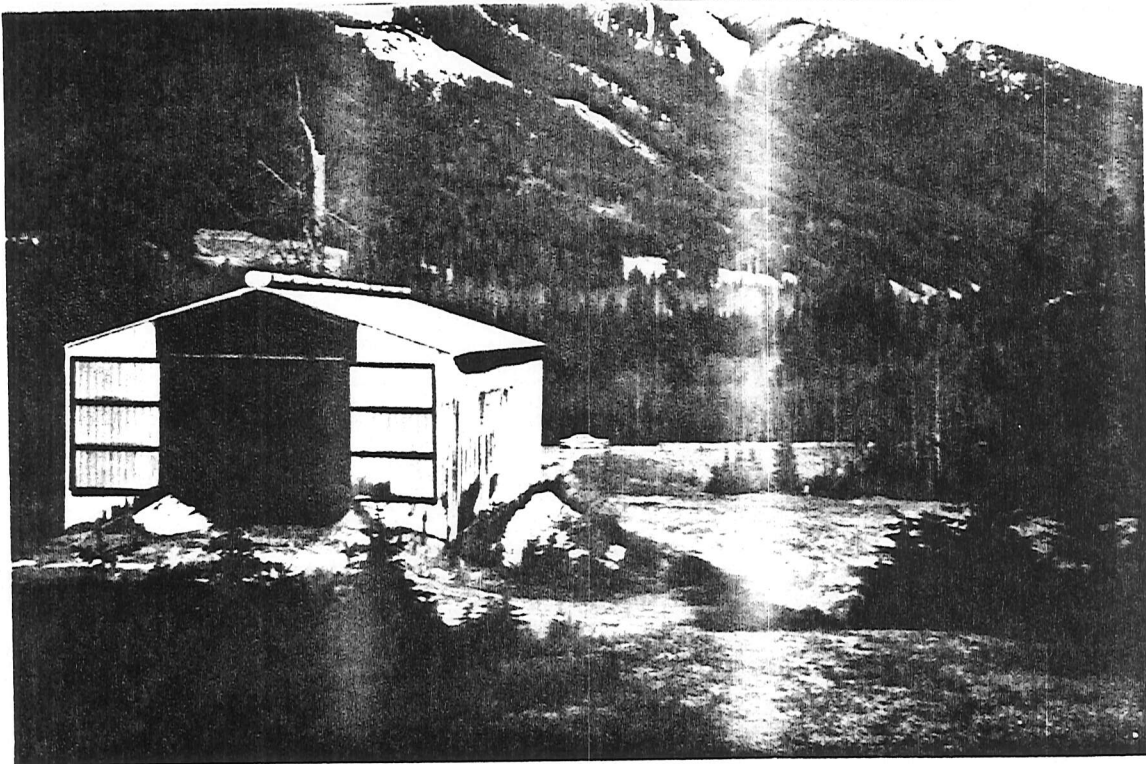
Proposed Beaver Picnic Site (Chip Shed will be removed).

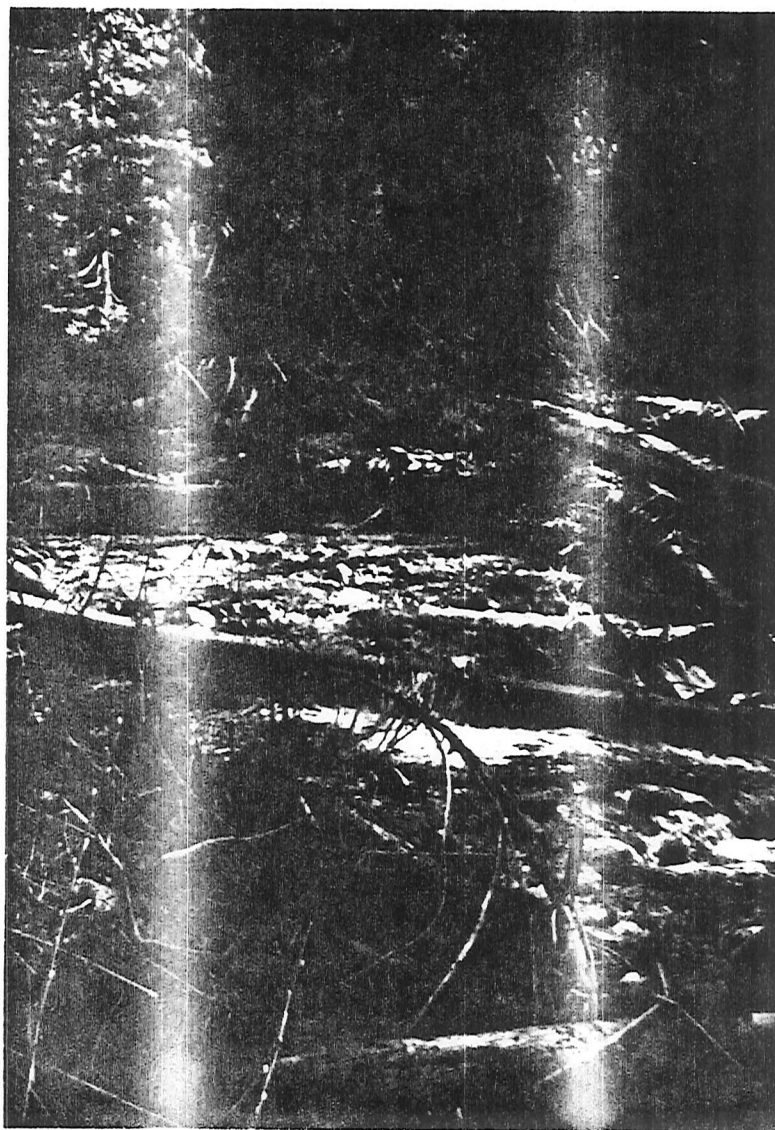
First Stream
Located just along trail
from the Picnic Site.

All five streams will need small bridges built because of their high banks and to deter the stream erosion caused by hikers and especially horses. The fourth stream is very unstable, with severe undercutting and erosion. There is no solid bed material.

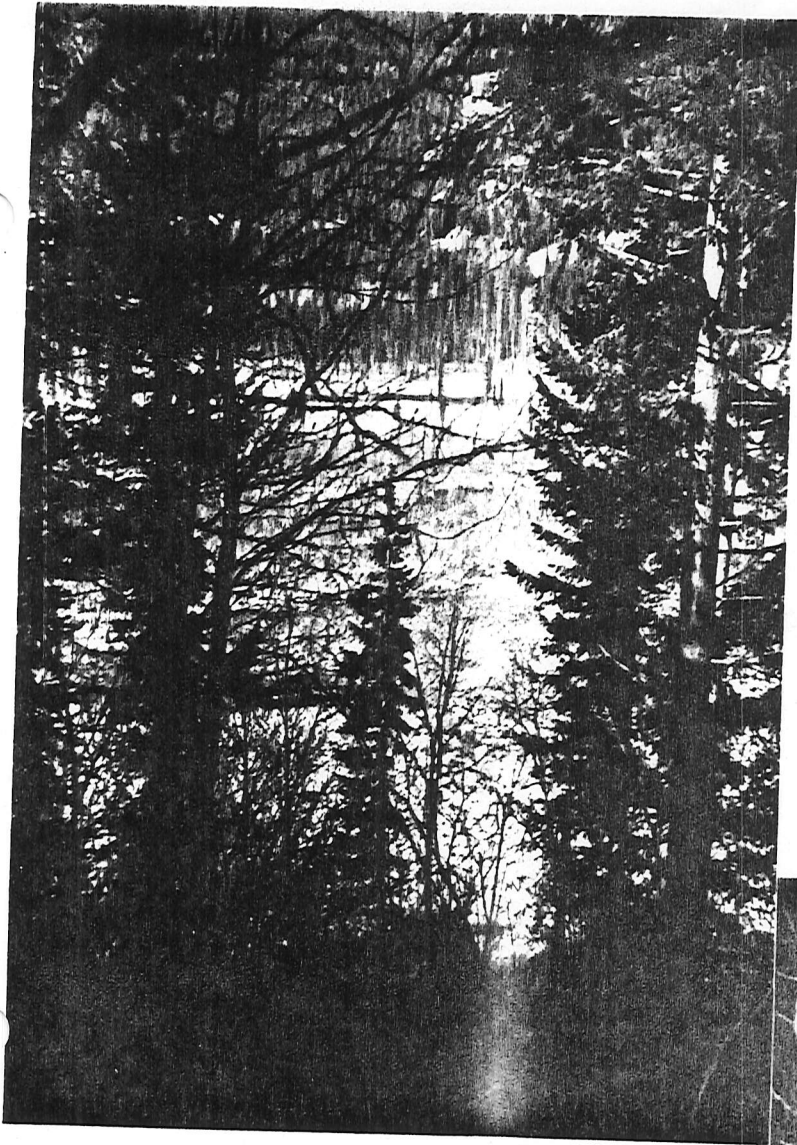
View of the Swampy Area
from the Trail (Ecosite $\frac{LR1}{5}$)

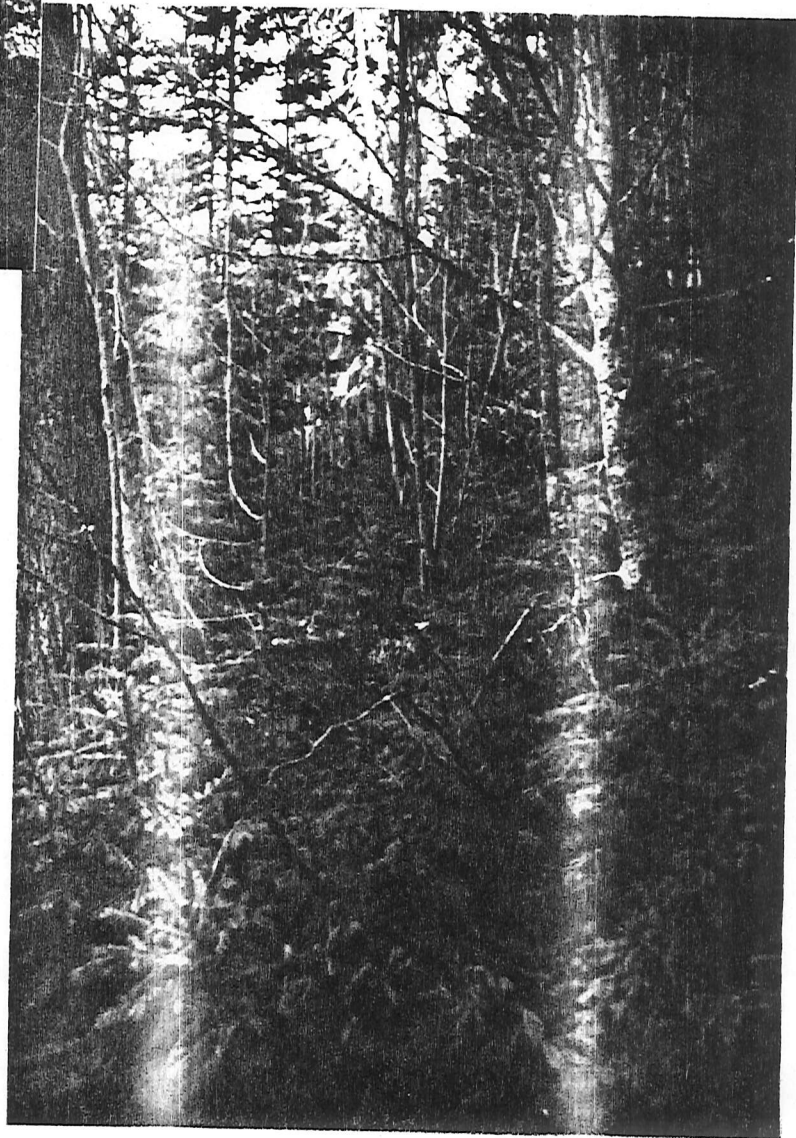
Extremely heavy
regeneration and
shrubs along the
trail.

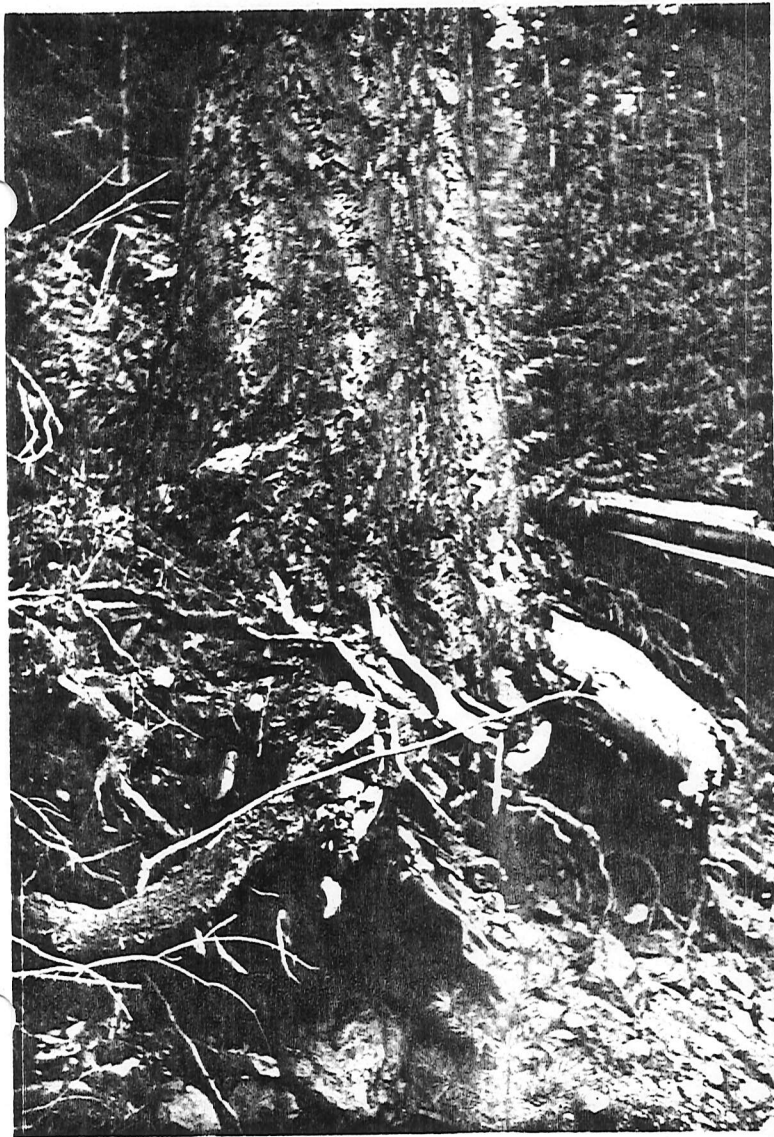
The current successional status of the area is mature climax Cedar / Hemlock Forest. The trees are also heavily infested with rot and disease. Most of the stand is very dangerous due to the high amount of windfall, and a tree hazard evaluation should be completed before construction begins.

Hazardous Trees are a top priority for the proposed trail.

- Before anything more is done on the trail, a hazardous tree evaluation should be completed. Hazardous trees are a public liability and those trees that are found to be exceedingly dangerous should be removed.
- In order to avoid bear / human encounters, the vegetation along the trail should be cut back so there is proper visibility in order to avoid any conflicts.
- Special attention should be given to the Fourth Stream, (coming from the proposed Picnic Site). This stream has been severely undercutting its bank and should be stabilized by constructing a "rip rap" along the stream edge or by channeling the water into a better stream.
- Constructing corduroys and small bridges will eliminate the damage to the wet / bog sections. The corduroys should be constructed from materials

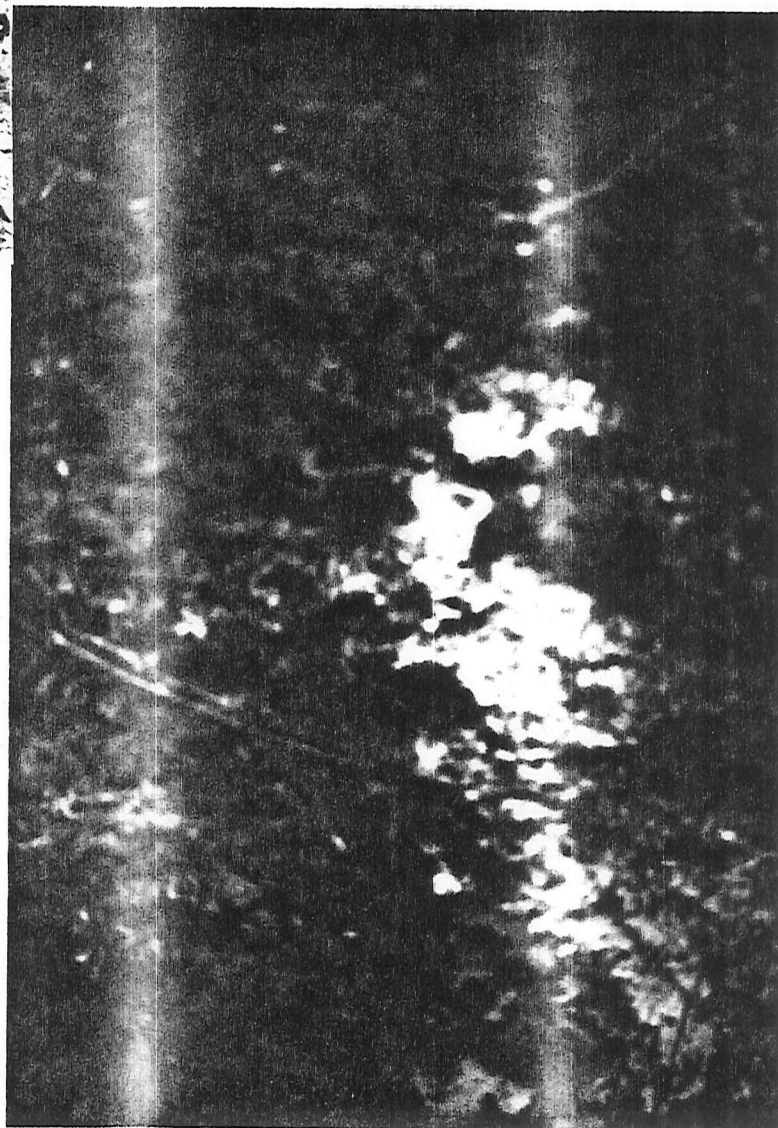
One of the wet, muddy areas along the first kilometer of the trail. These should be corduroyed.

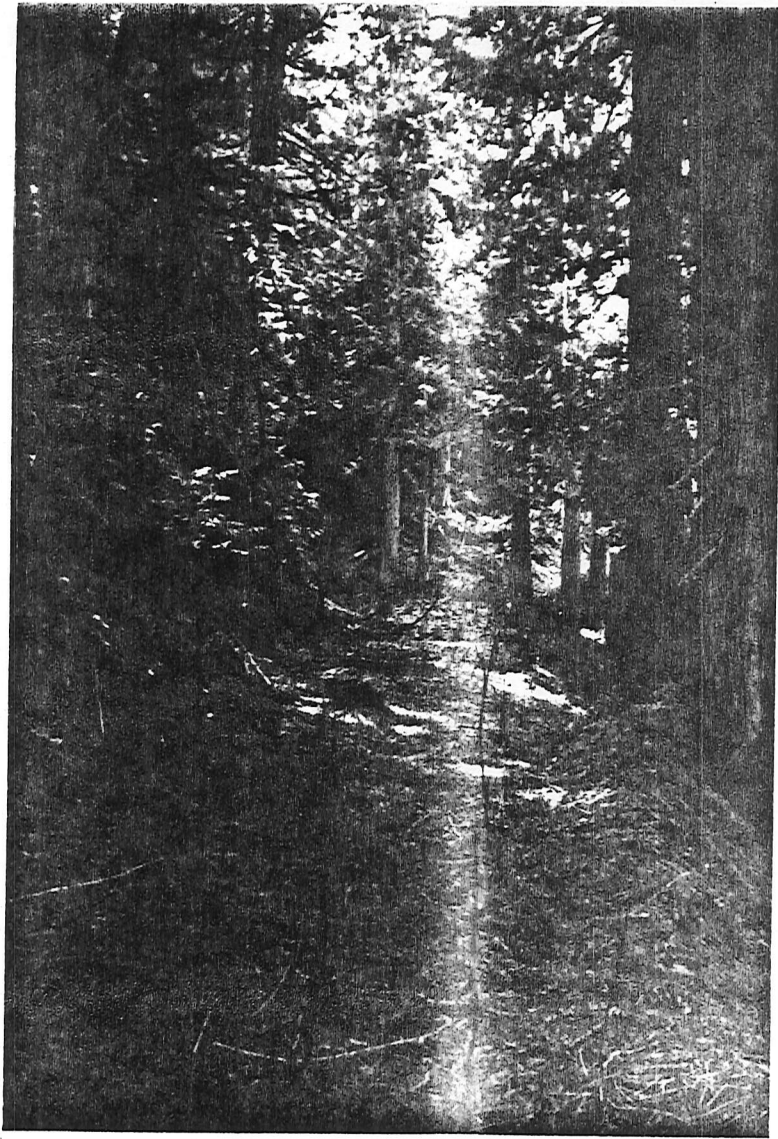
The trail begins to clear
in the second kilometer.
(Note the width of the
cut in the bank.

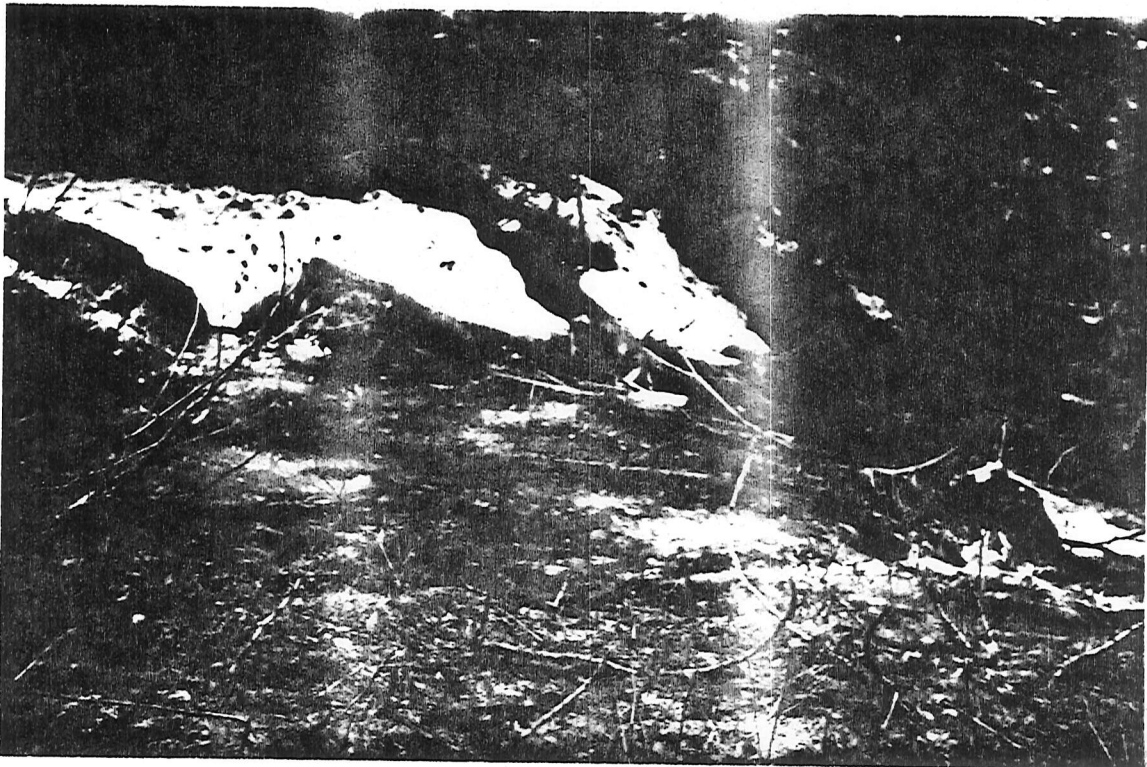
The second stream. Fairly unstable and in need of a bridge.

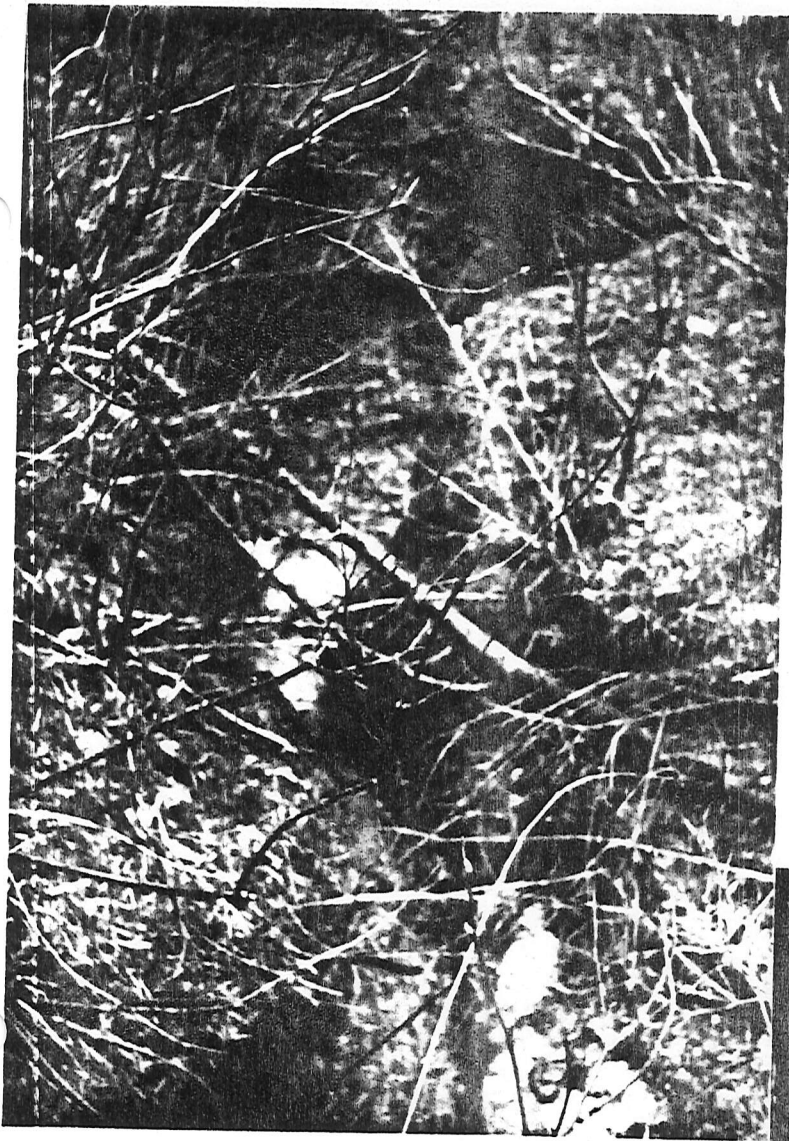
The fourth stream in from the Picnic Area. Very unstable. This stream was formed by a flood that went through the area in 1983.

This stream was believed to have been created by a flood that went through the area in 1983. Crossing this stream is no problem now but I recommend a bridge be built and some kind of 'Rip Rap' be installed in the bank for safety reasons and to lessen erosion.

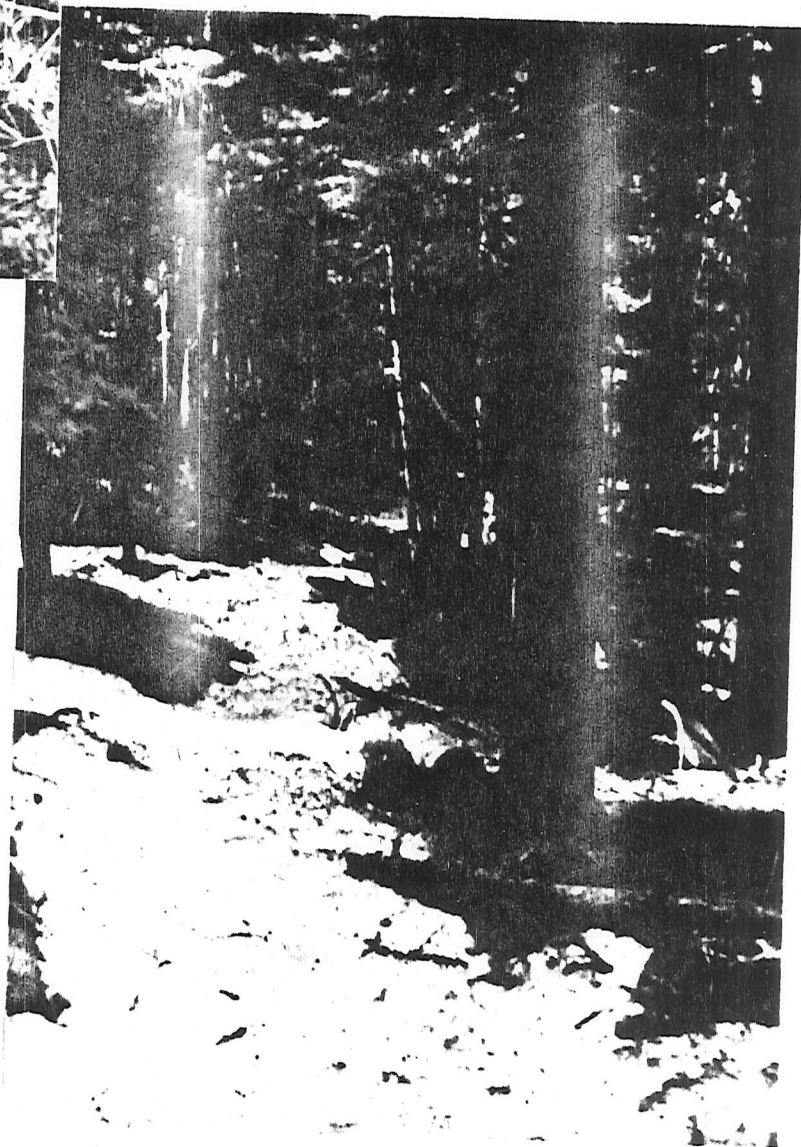
The third kilometer is in very good shape. Little clearing is needed and the width is adequate.

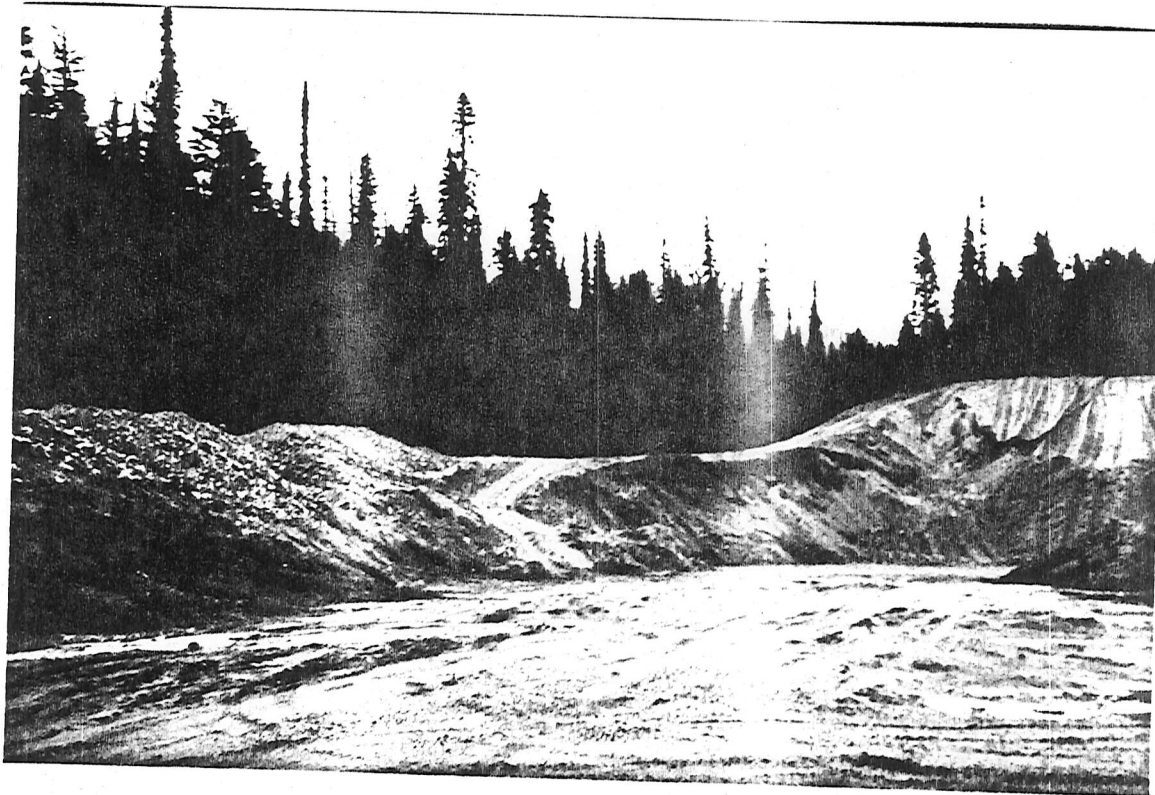
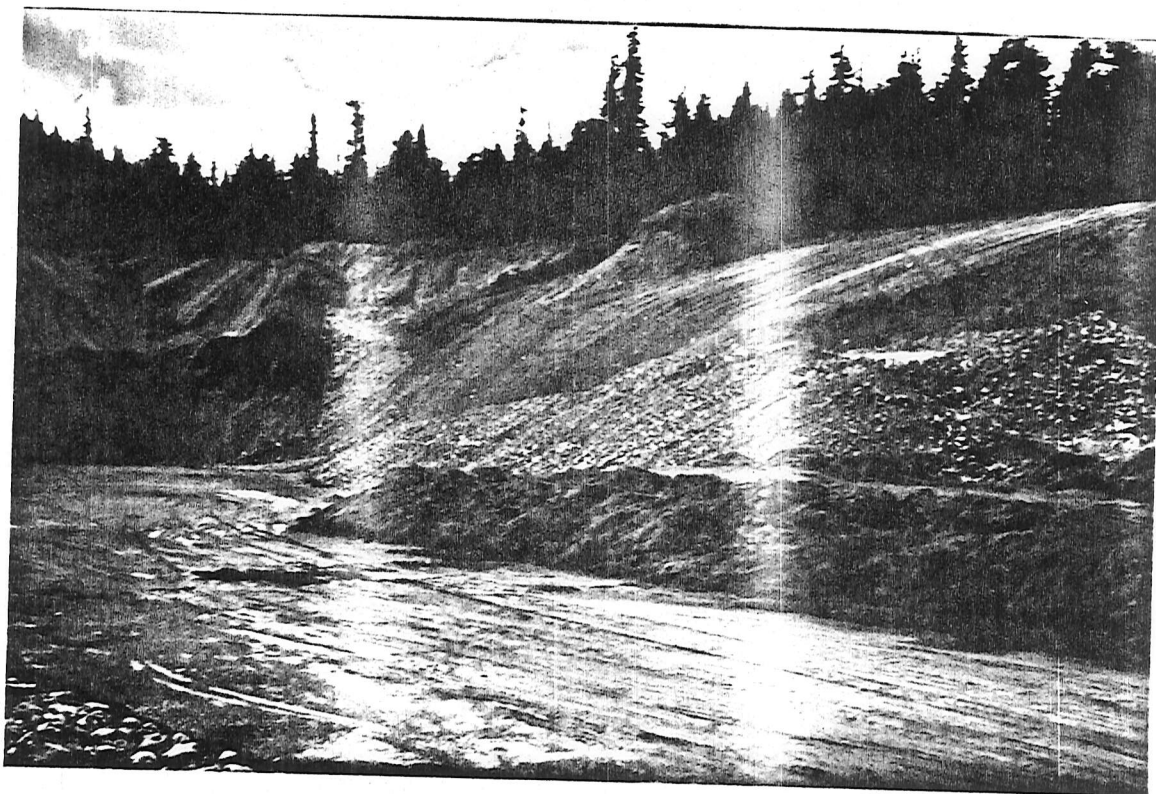
The Beaver Gravel Pit.

The major problem for this new trail extension is the Beaver Gravel Pit. The pit is currently being used to supply the gravel needed for the highway. The problem is that in order to join the new Beaver Gravel Pit Trail up with the Beaver Valley Trail, it has to go directly through the middle of the gravel pit. There are three possible options

The Beaver Gravel Pit is perhaps the biggest problem for the proposed trail. A visual impact and a major environmental impact, the Beaver Pit should be replanted and made presentable in the areas of the pit that are no longer being used.

- 1) re-route the beaver pit trail around the gravel pit.
- 2) re-locate the new trailhead for the Beaver Valley trail behind the 'Cana' cement mixing site. Once that site has been reclaimed and cleaned up.
- 3) route the Beaver pit trail through the gravel pit.

Before any trail construction starts, the Park must decide whether the trail is going around or through this area.
