Highway Mortality Of Mule Deer And White-tailed Deer

# ABSTRACT

Discussed within this report is the current knowledge of deer-vehicle accidents and the solutions that have been tried. The author has discussed and given possible solutions and final recommendations to the current literature. From this literature the Grand Forks area was accessed and the best possible solution for the lowest cost was recommended to produce a workable study plan for the area.

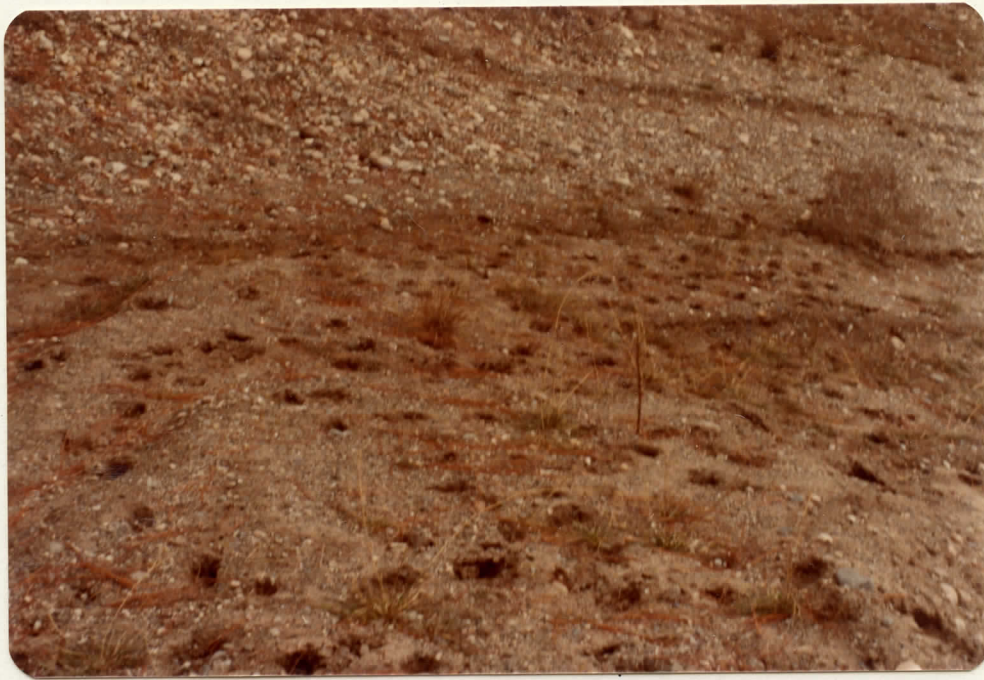
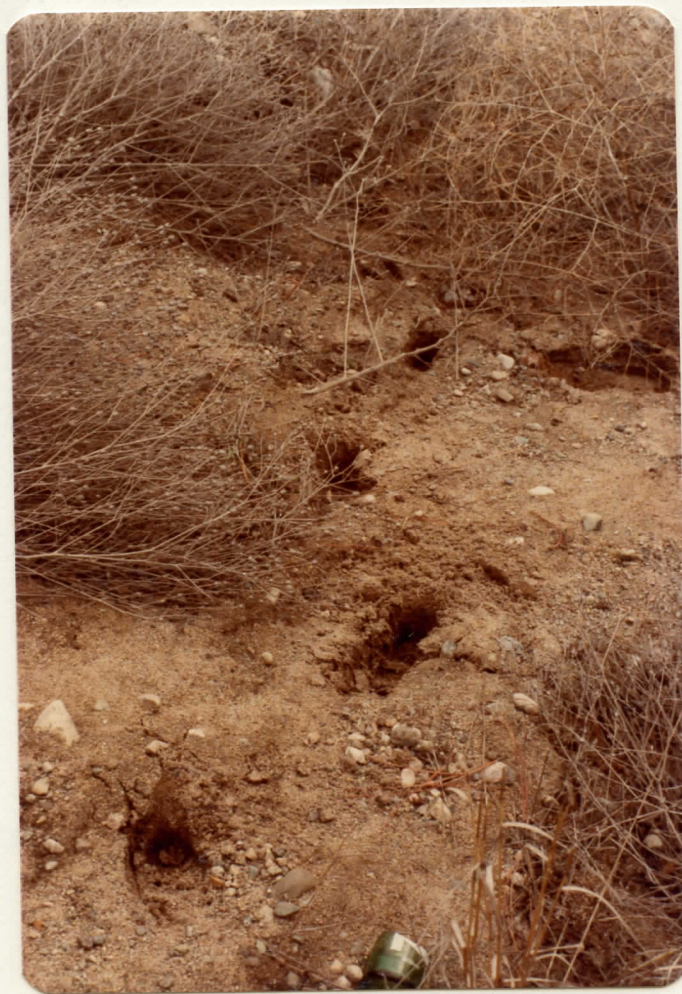
Figure # 5

Deer tracks found along the banks of highway # 3.

The problem area locations have been investigated by the author through counts of tracks and actual sightings of deer (see Figures #5 and #6). Also, fence crossings by deer were determined by locating

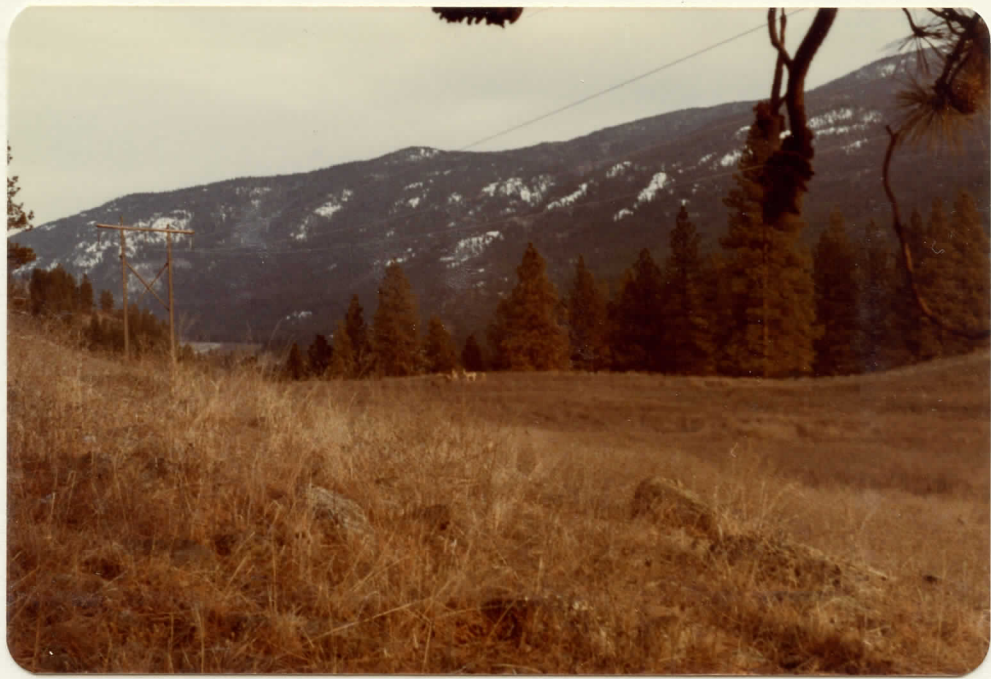
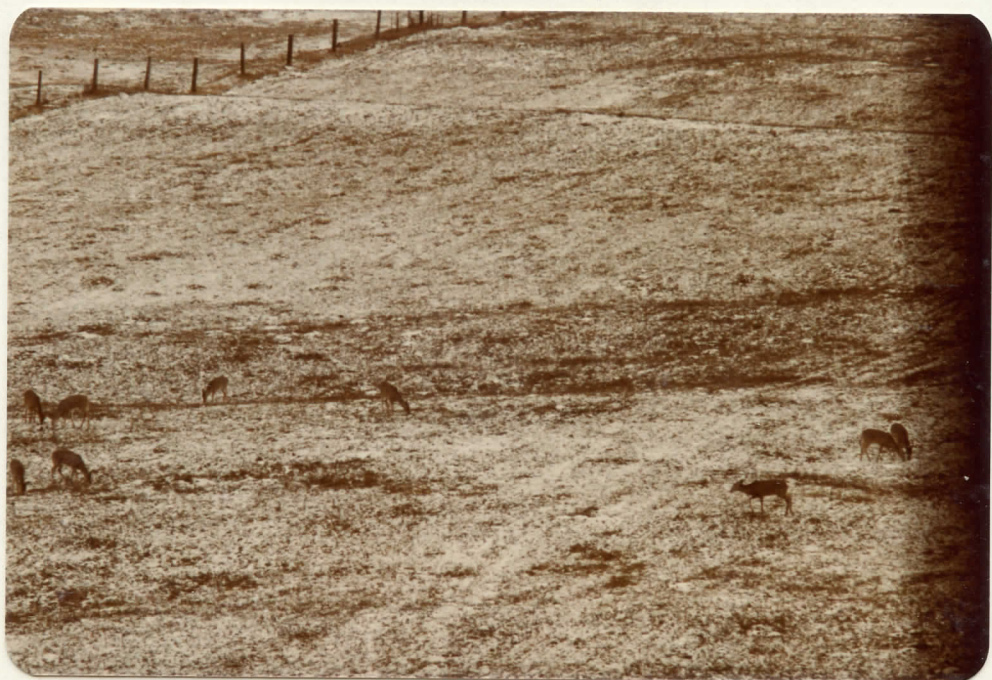
Deer feeding on upper and lower pastureland of highway #3

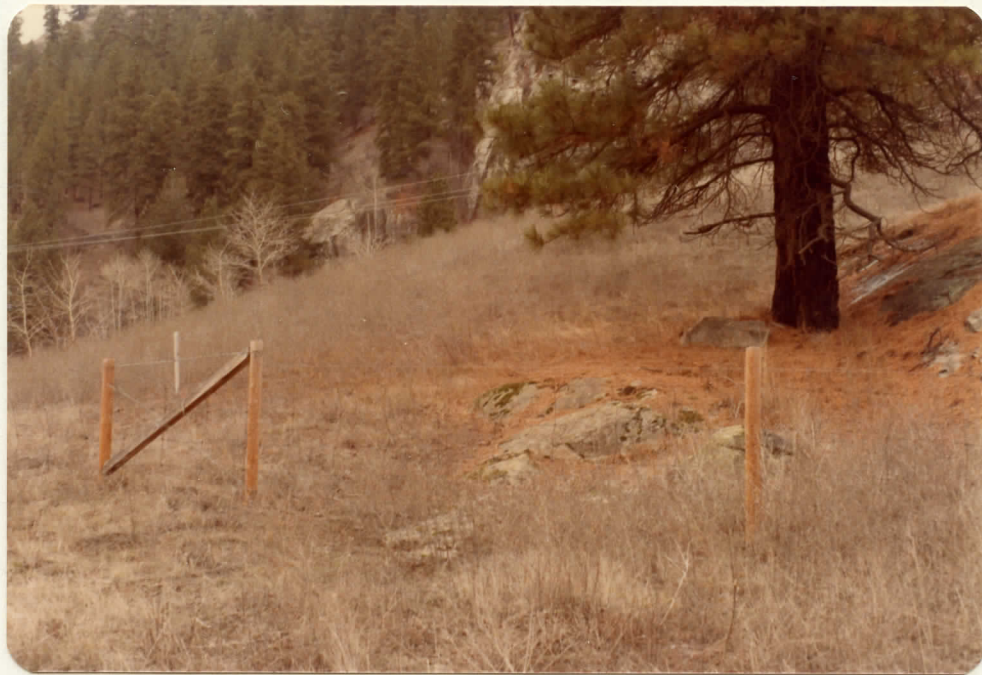
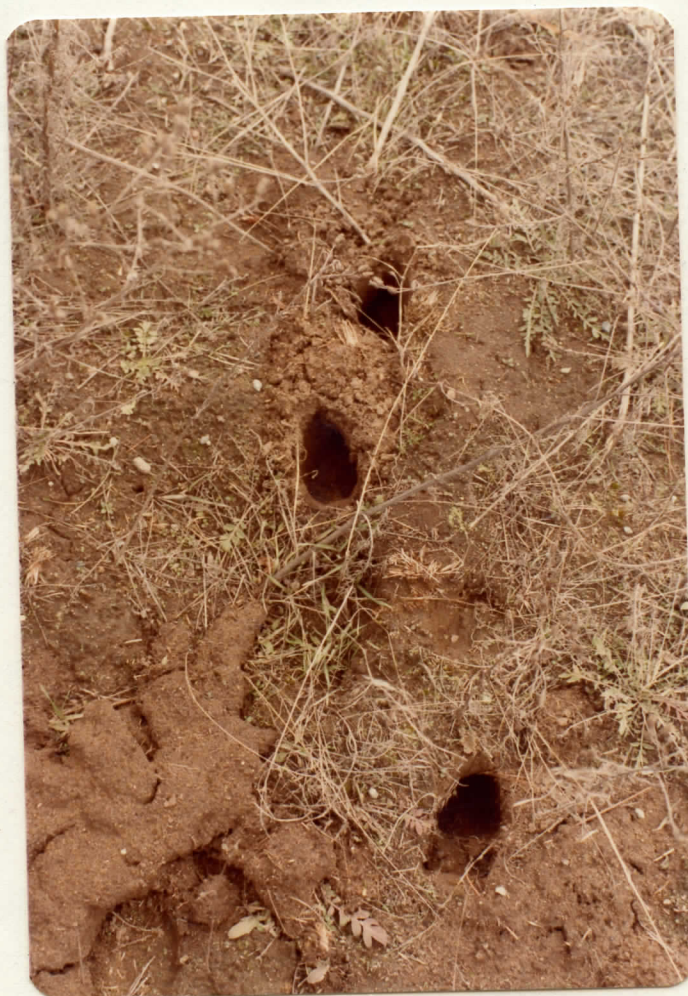
Figure # 7

Fence jumped over by deer, indicated by deepened deer tracks

deepening tracks (see Figure #7) and by tracks leading over down fences and undercut fences (see Figure #8).

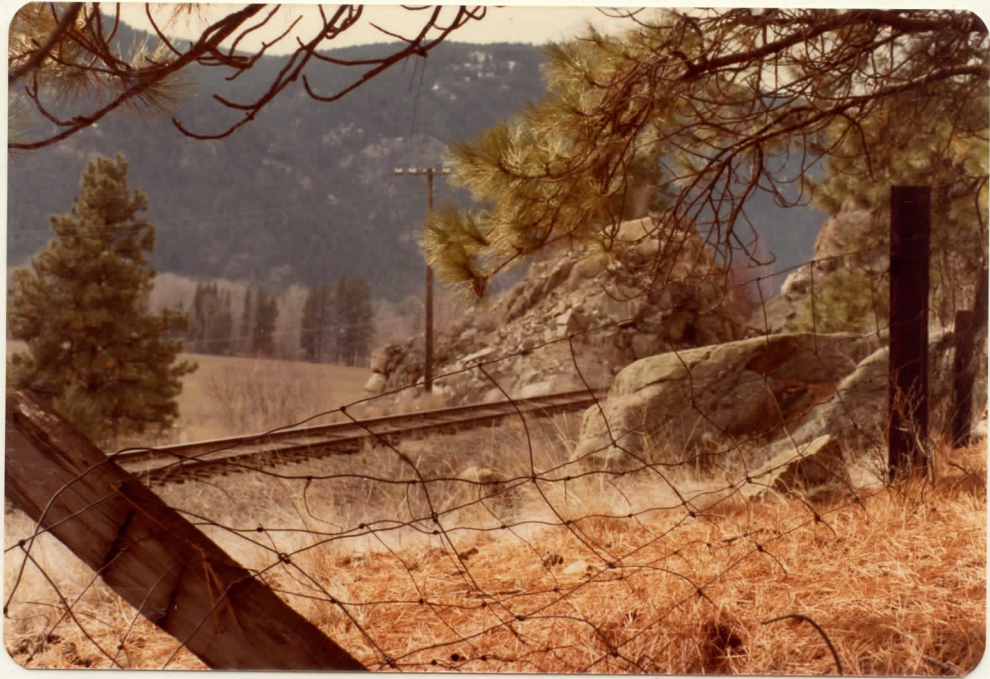
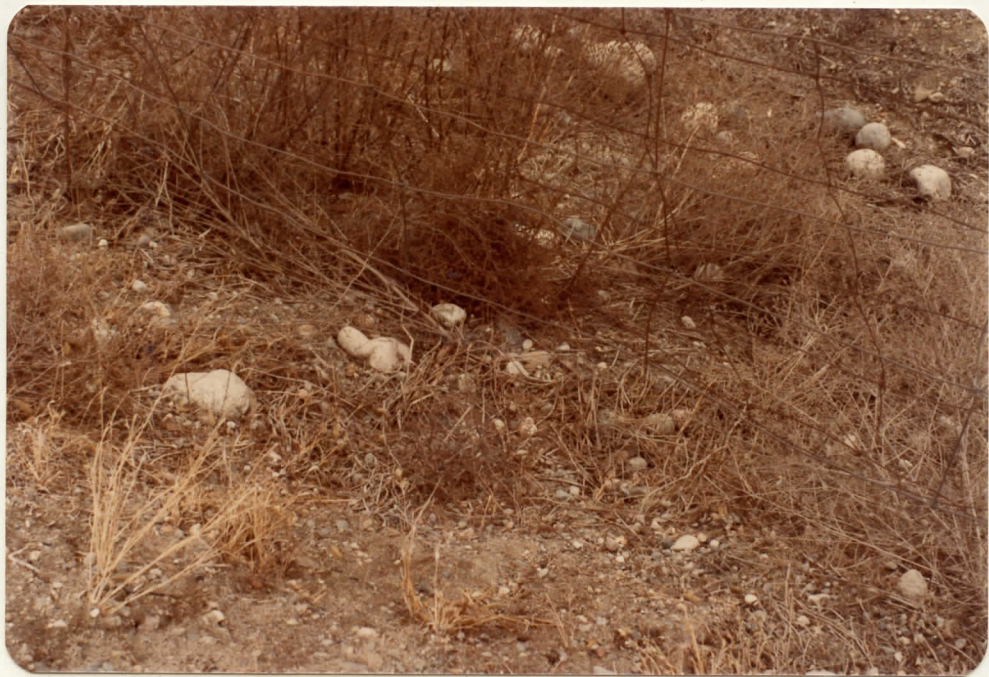
Figure # 8

Down fences and undercut fences used by deer along highway # 3

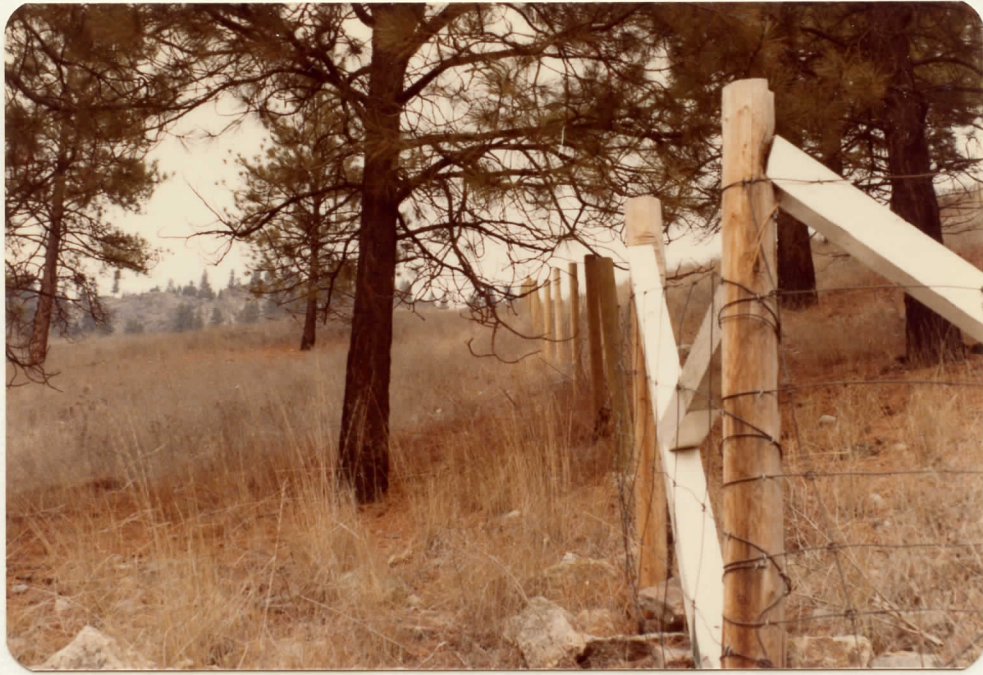
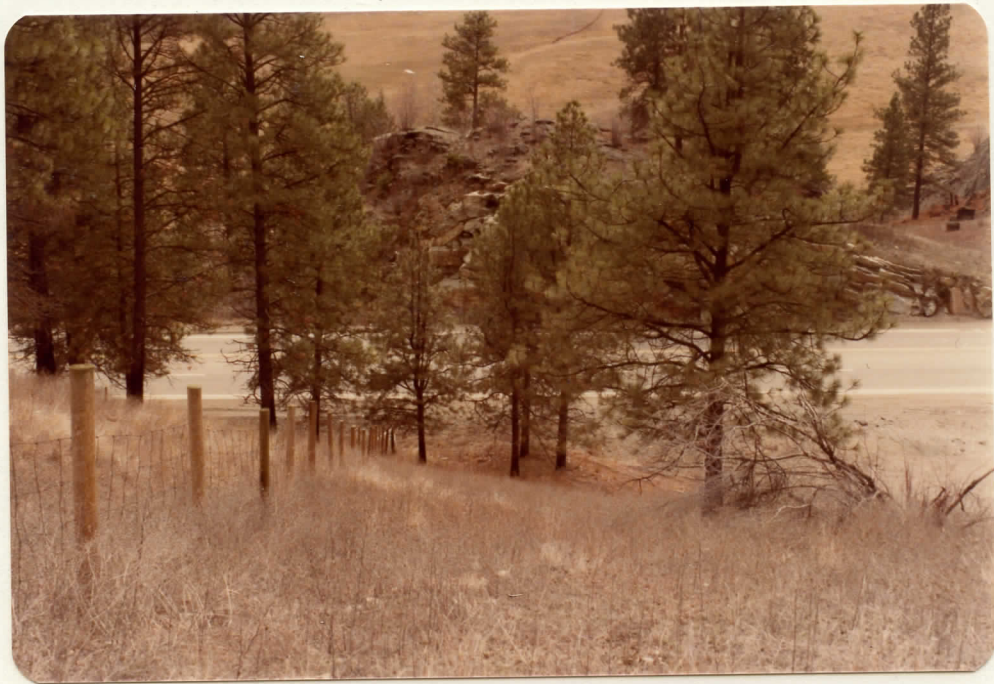
Figure # 15

View of cattle fence from the road and from the top

cattle fence, down to the north side of the highway (see Figure #15). The cattle fence continues uphill for 30 metres before it levels off, at which point the deer jump over the fence with ease (see Figure #16). On the south side of the highway, a fence enclosing the railway is the only obstacle to deer travelling the lower pastures and the river (see Figure #17). Also, portions of this fence are down, and other portions permit deer passage beneath the fence (see Figure #8). The remaining 3 kilometres east of the rock walls consist of large pasture areas on both sides of the highway, which deer cross readily in search of more available food and water.

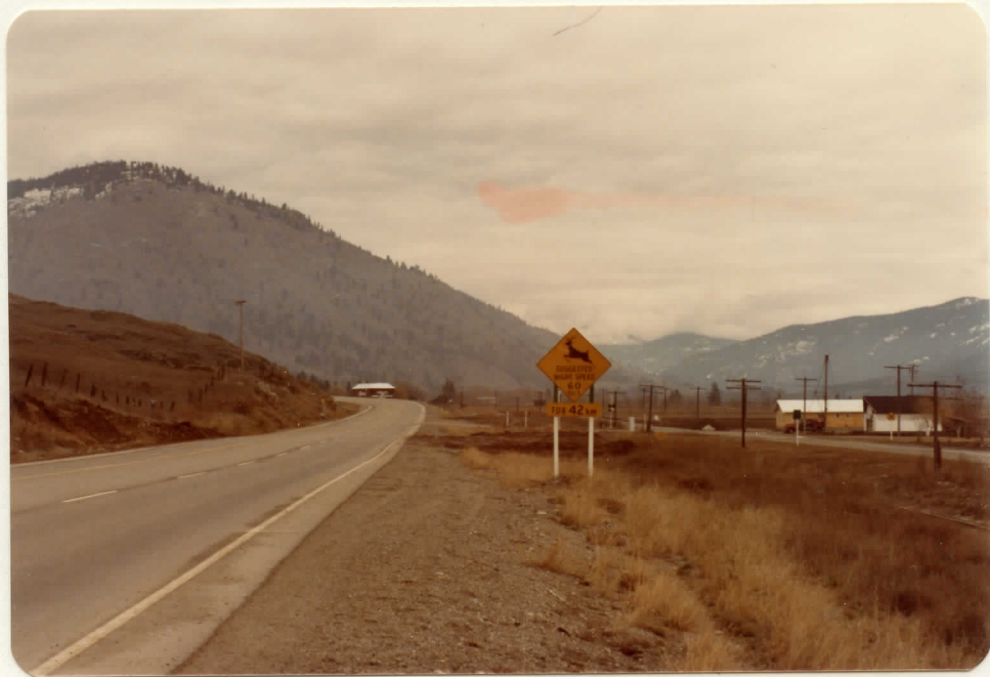
Figure # 21

Deer crossing sign at the two kilometer marker, heading  
east from Grand Forks

To date the only solution used has been oversized deer crossing warning signs (see Figure #21), but as previously indicated in the literature by Pojar, Prosence, Reed and Woodard, warning signs may not significantly reduce average vehicle speed. So although the warning signs are larger and more impressive, it is likely that little attention is given by passing motorists.
