LIMNOLOGICAL  
INVESTIGATION  
OF SELECTED  
KOOTENAY  
MOUNTAIN  
LAKES

SUMMER 1981

JOHN JOSAFATOW  
IRENE WEST  
DOROTHY WRAY

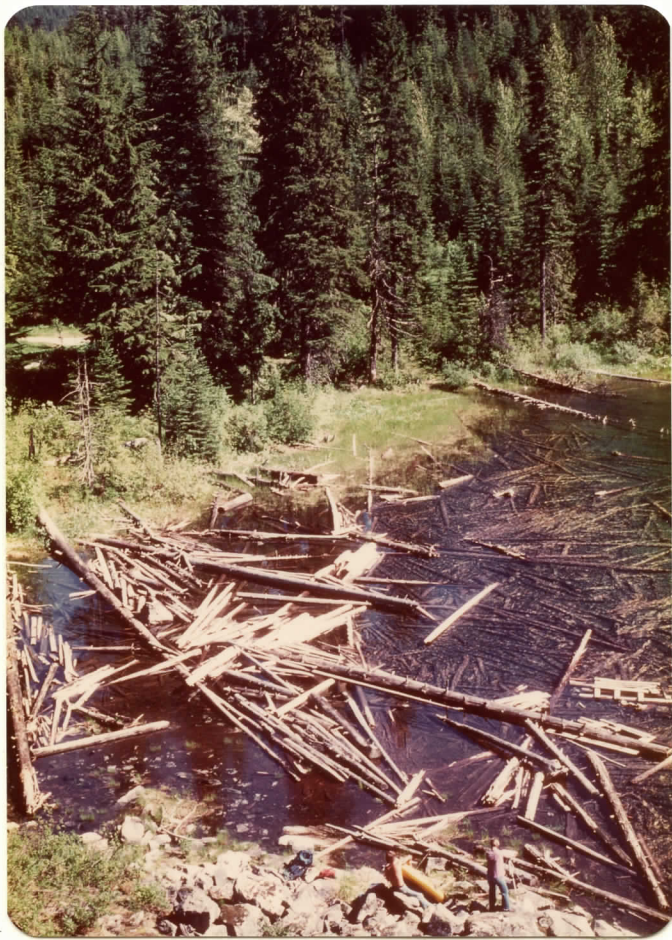
Log debris at outflow.

Log debris was abundant around the entire shoreline but was primarily concentrated at the head of the outflow stream. Evidence of previous beaver activity was found along the northwest shore.

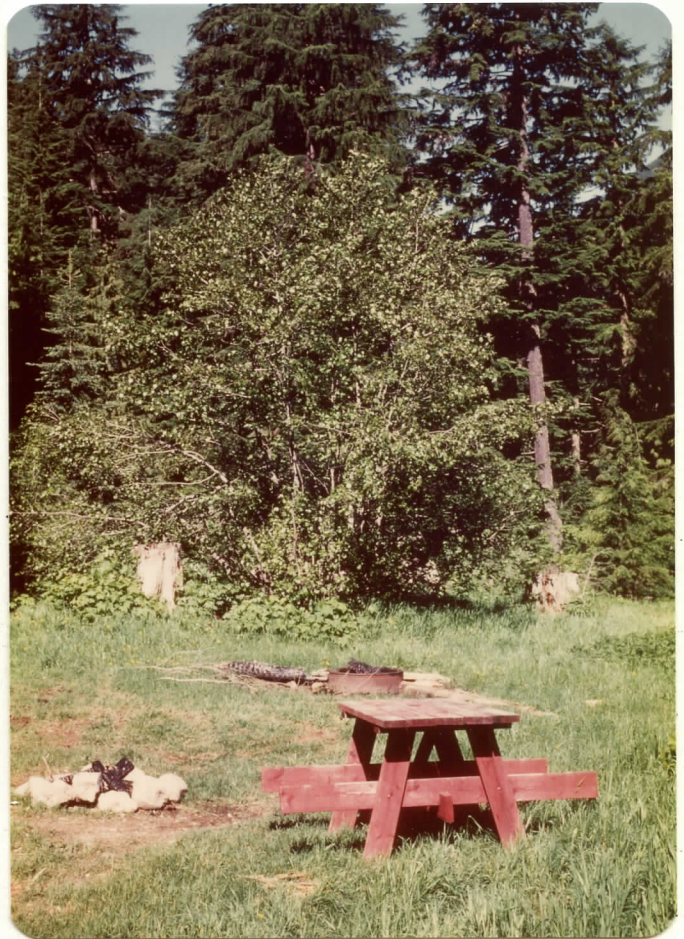
B.C. Forest Service campsite.

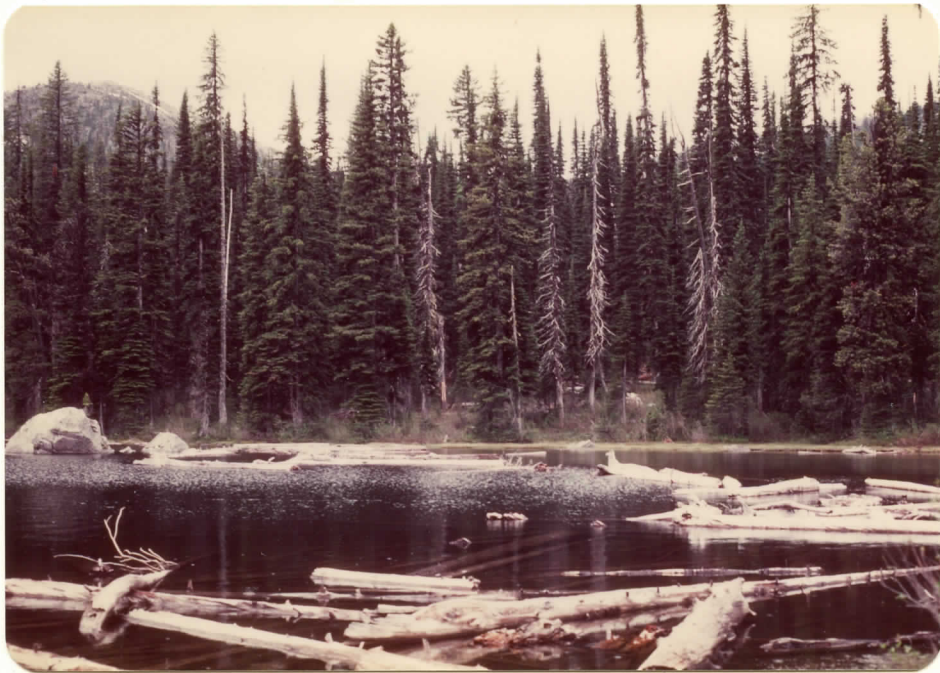
Log debris at outflow.
