MANAGING THE FISHERY AT CHAMPION LAKES PROVINCIAL PARK

Gary McCall

WILDLAND RECREATION 271

April 15, 1982

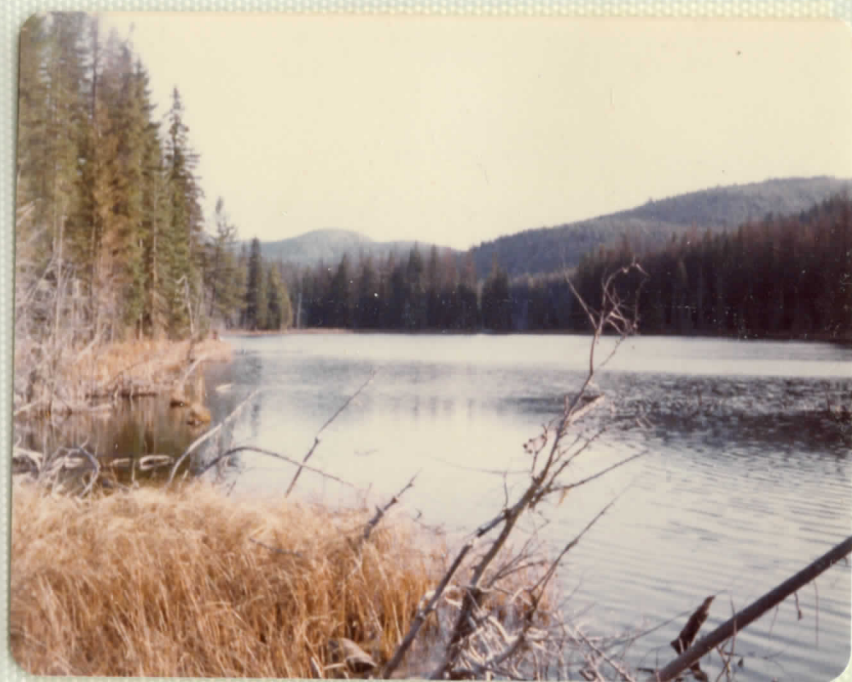
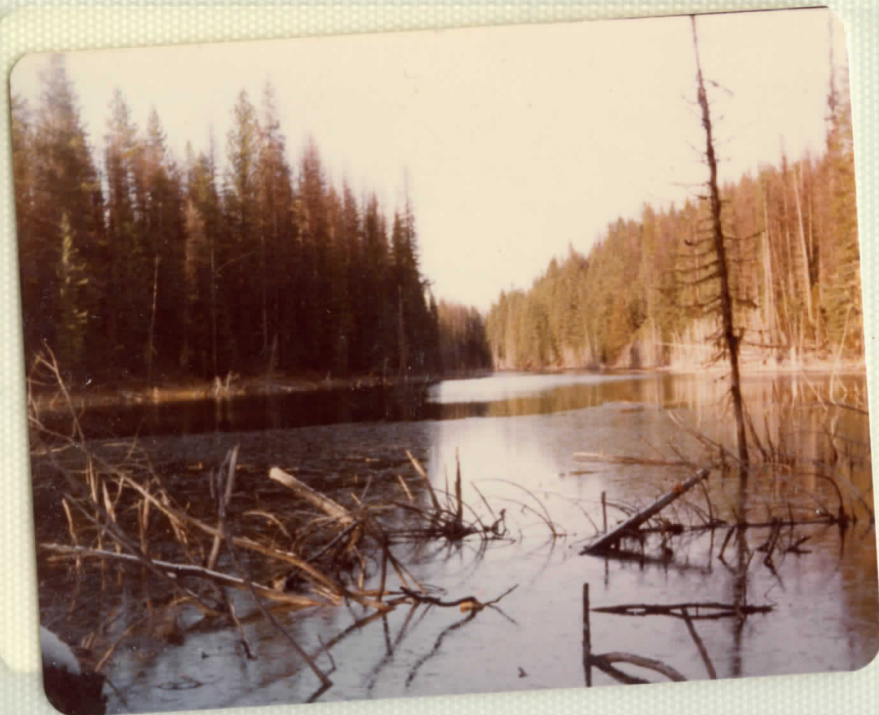
-30-

1. TOP LEFT: Third Champion Lake, beach/day use area at left side of picture.
2. TOP RIGHT: Second Champion Lake
3. BOTTOM LEFT: First Champion Lake

Stream 5, the outlet of this lake system, is criss-crossed by large fallen trees. (See Fig. 9 (8, 9). These trees are, for the most part, above the stream and do not impede the flow.

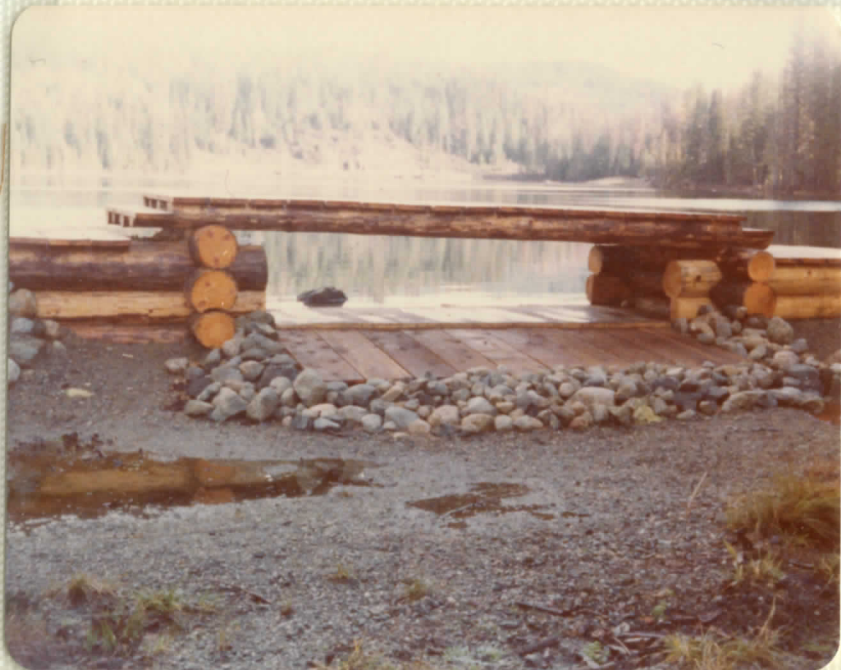
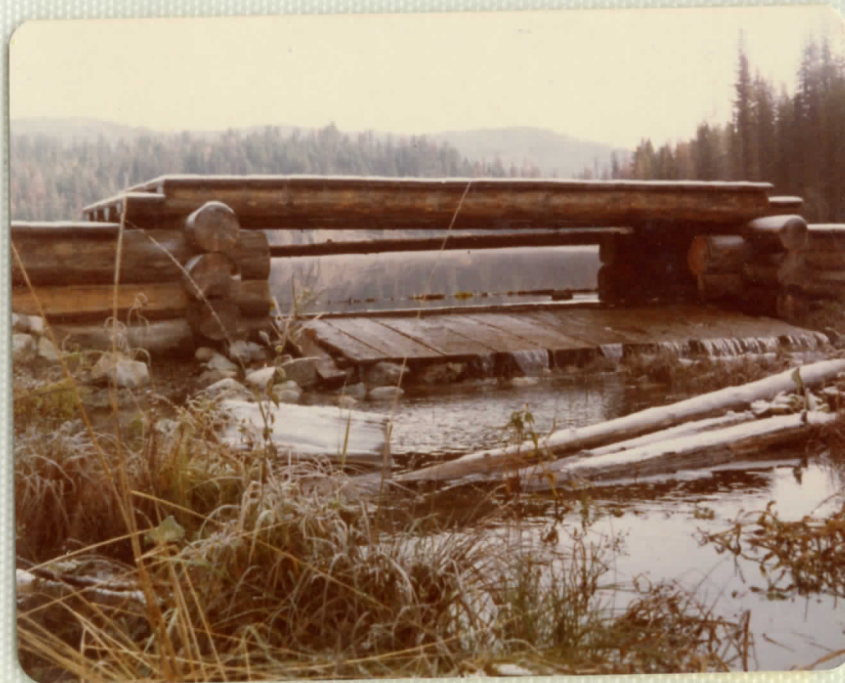
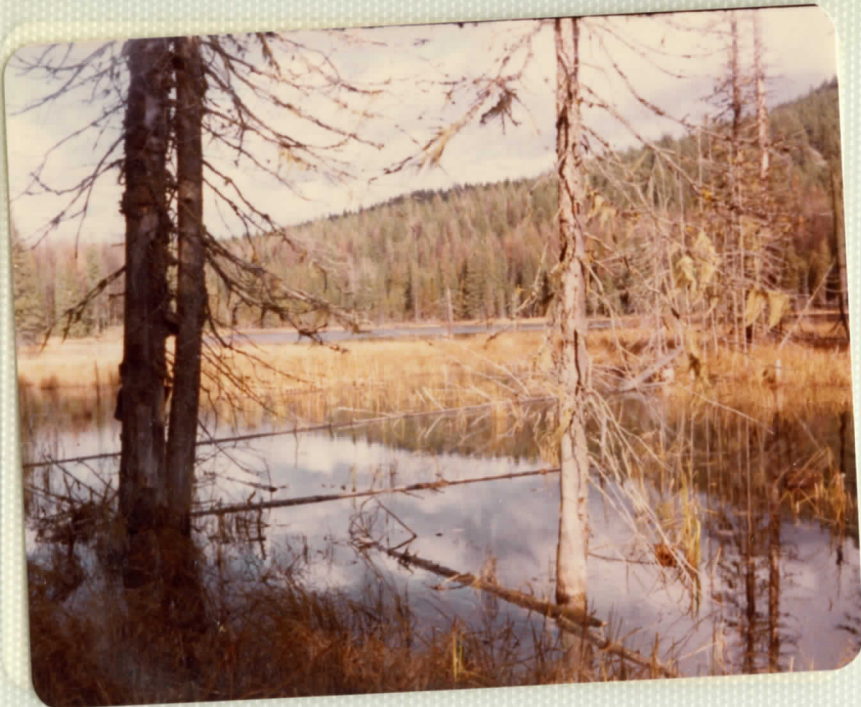
FIGURE 8

4. TOP LEFT: Wooden dam at outlet of Third Lake in mid September. Flow is non-existent.
5. TOP RIGHT: Same dam in mid-October. Some flow is present.
6. BOTTOM LEFT: Inlet to Second Lake.

Stream 3 - This channel connecting Third and Second Lake is approximately 550 m in length. It does not contain water year round, so spawning conditions are poor. A small wooden dam at the outlet (See Fig. 8) constructed to control the water level at Third Lake, restricts or prevents entry and exit to this channel during low flow periods. The channel has little streamside cover and the bottom is mainly a buildup of muck. Three sets of measurements were taken along the length of this channel: 1) the first one below the dam at the Third Lake outlet, 2) the second halfway between Second and Third Lakes, and, 3) the third near where it enters Second Lake.

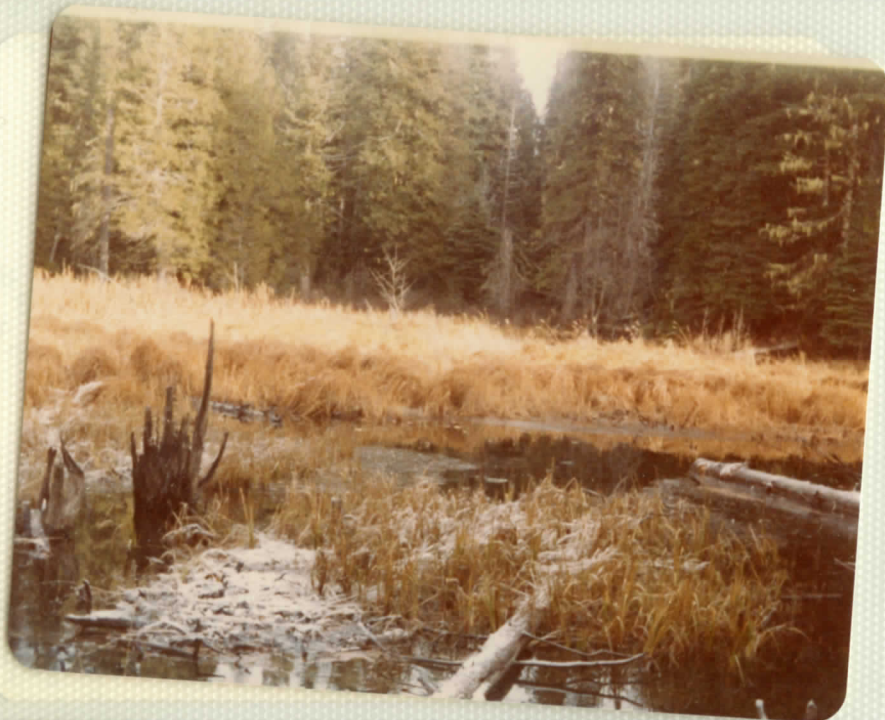
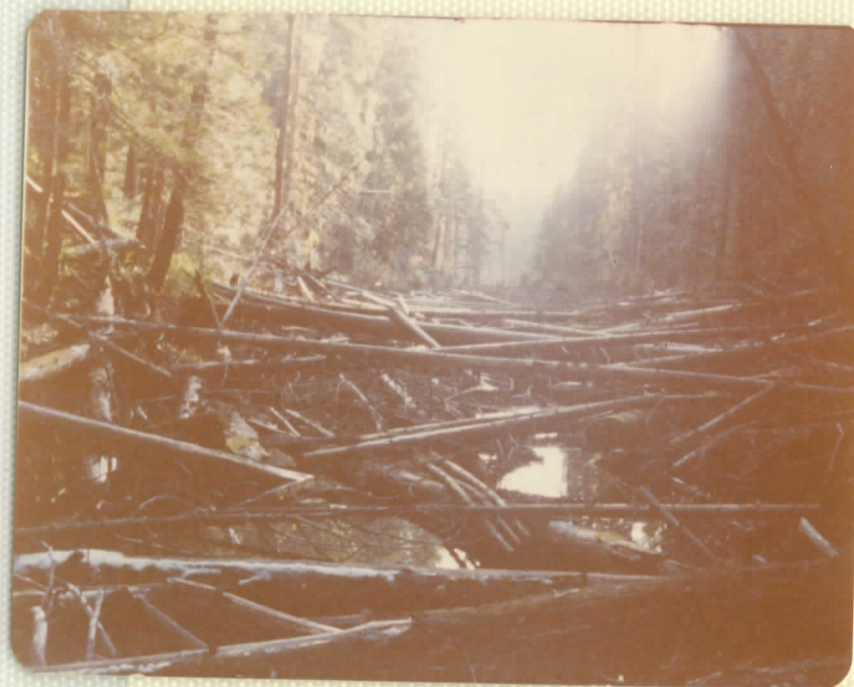
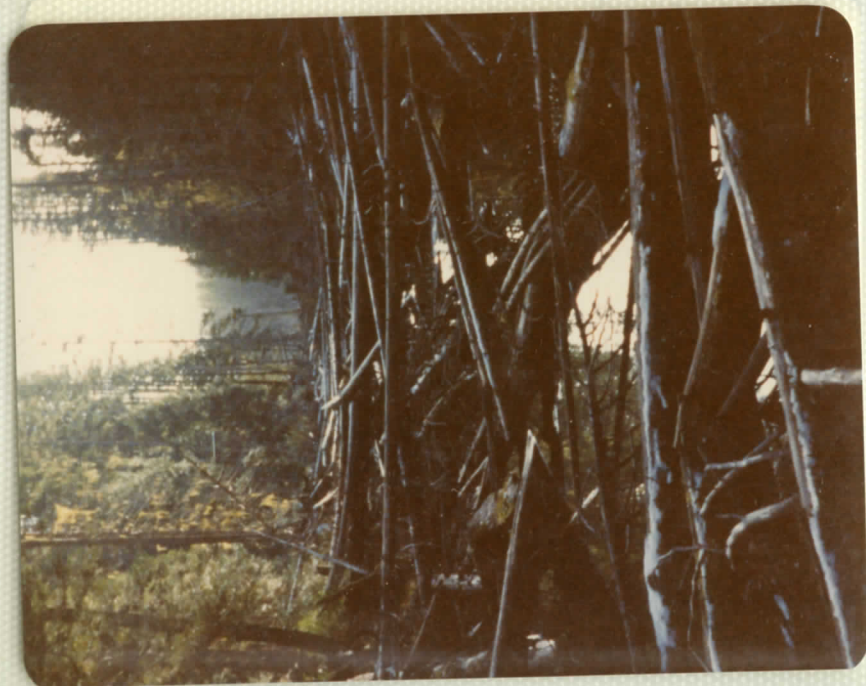
FIGURE 9

7. TOP LEFT: Marshy area at inlet to First Lake.
8. TOP RIGHT: Outlet of First Lake (Landis Creek). Many of the logs span the width of the creek without obstructing flow.
9. BOTTOM LEFT: Another shot of Landis Creek.

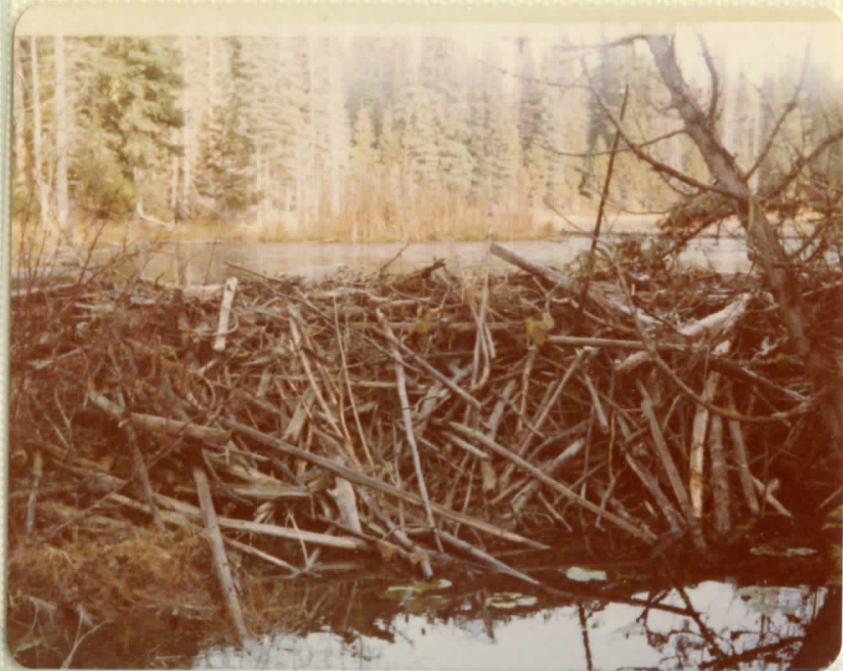
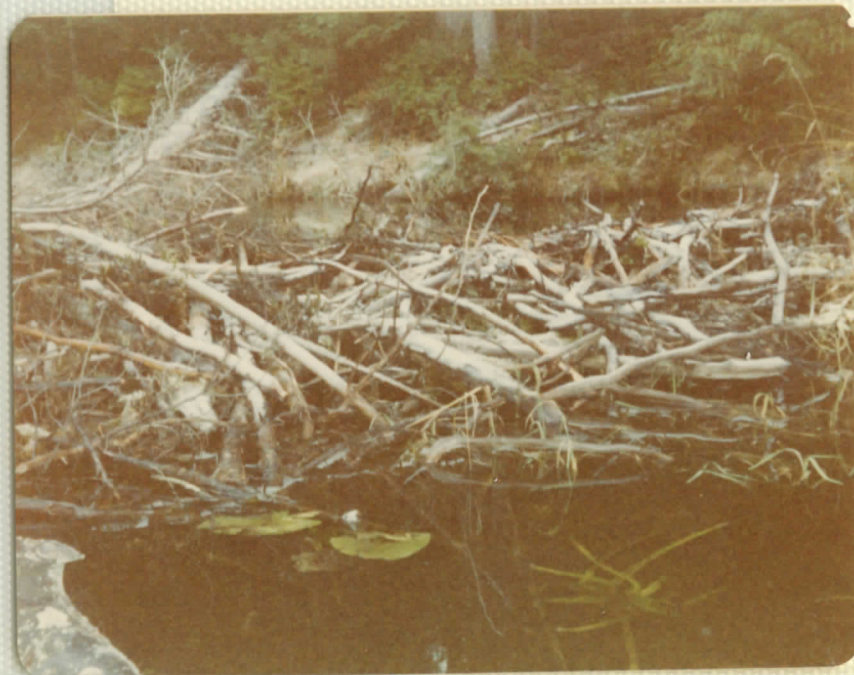
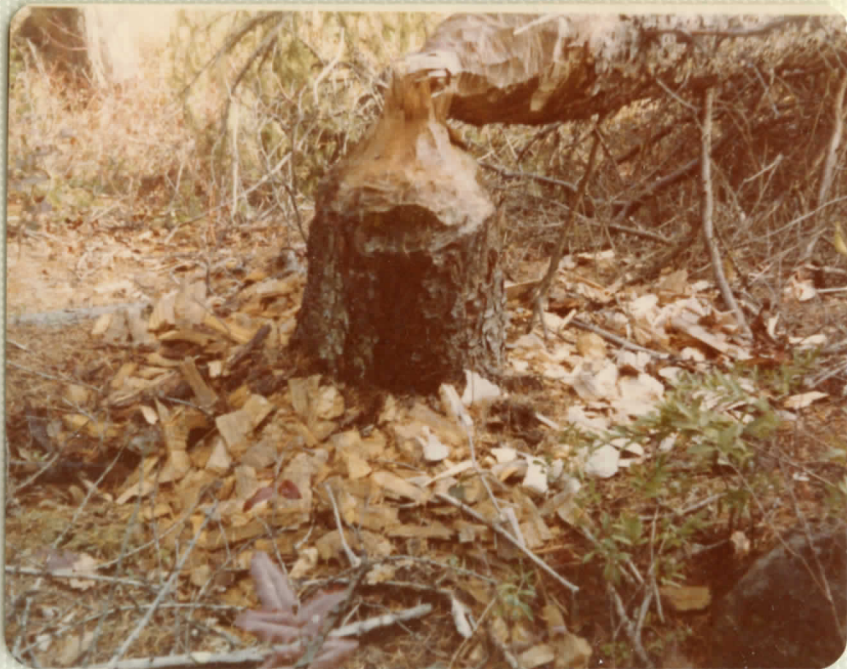
FIGURE 10

10. TOP LEFT: Beaver dam blocking outlet of Second Lake. It is approximately 6 m. wide, 1.5 m. high.
11. TOP RIGHT: A smaller dam along the channel connecting Second and First Lakes.
12. BOTTOM LEFT: Evidence of recent beaver activity near First Lake.

MEASUREMENT #1 - Taken just below beaver dam at the outlet; Beaver dam is approximately 6 m wide, 1.5 m. high.
